Test Intention:

In test 5042 we want to investigate the lifespan of a CF891.25.04 in an e-chain with a 125mm radius

Name: C. Mittelstedt Team: chainflex® Date: 18.09.2015

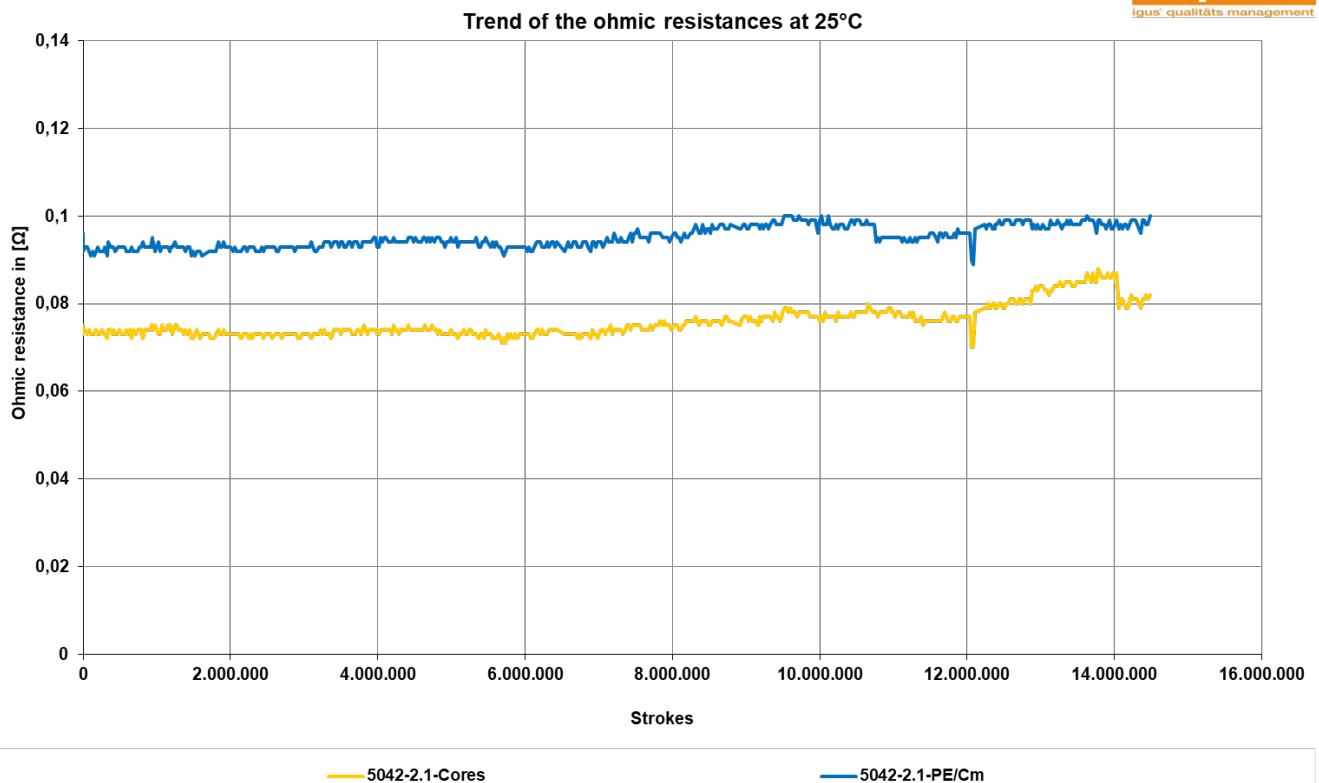
5042-

The following diagram shows the trend of the ohmic resistances during the test:

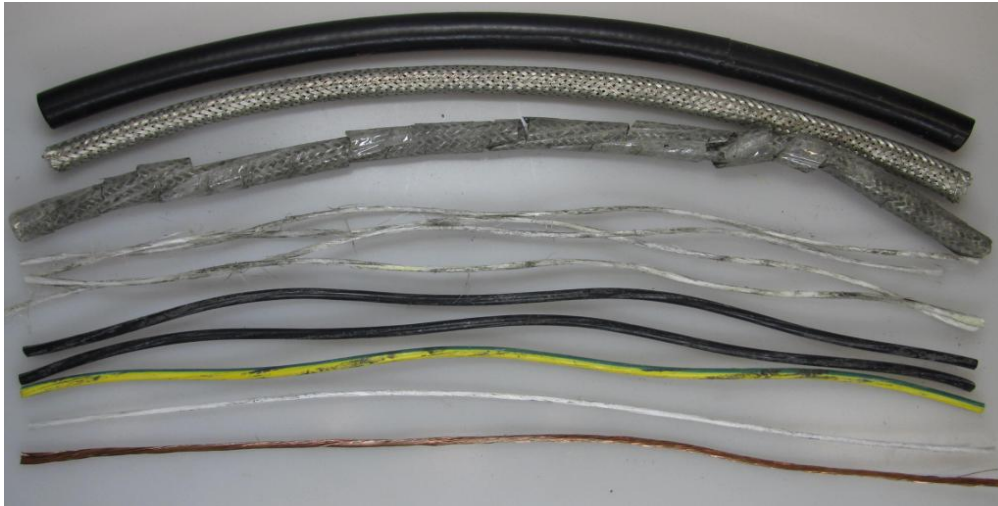
The condition of the cable no. 1.1 (CF891.25.04) after 14.466.934 strokes

| Condition banding | Ruptured |
